**MicroVision Labs Coal Ash Report, Job Number: 13409**

**CDW Consultants, Inc. Project Number: 1830**

**CDW Consultants, Inc. Project Name: Beaver St**

This report covers the methods and findings of the Coal/Coal Ash analysis that MicroVision Laboratories, Inc. conducted on Three (3) soil samples submitted for testing from the Beaver St project, number 1830. The purpose of this analysis was to detect and document any coal, coal ash, wood ash or asphalt that may be present in the submitted soil samples by use of a combination of microscopy techniques including SEM/EDS, PLM, and macroscopic inspection.

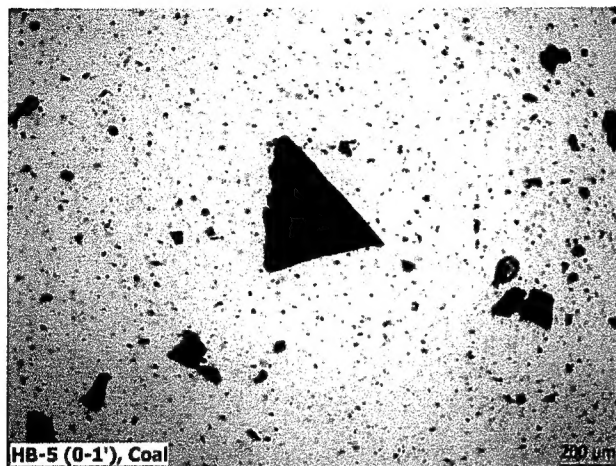
**PLM Image**

**Coal:** This particle type consisted of eleven (11) shiny, black grains approximately 1-3mm in diameter. The PLM examination indicated this particle type to be consistent with coal. The PLM and SEM images of this particle type show the angular edges and typical conchoidal fractures found in coal.

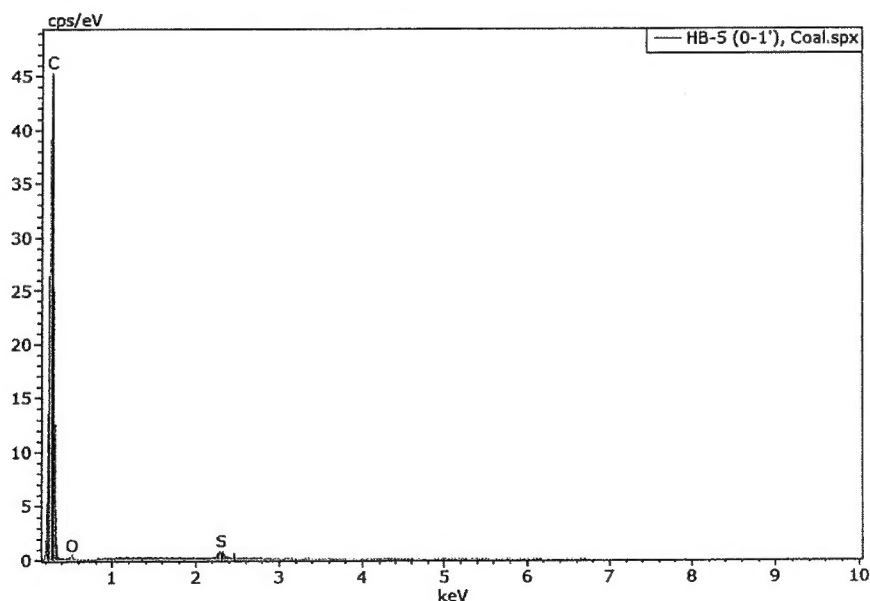
The EDS spectrum, shown below, confirms that this particle type is coal. The analysis for this particle shows concentrations of carbon, oxygen and sulfur.

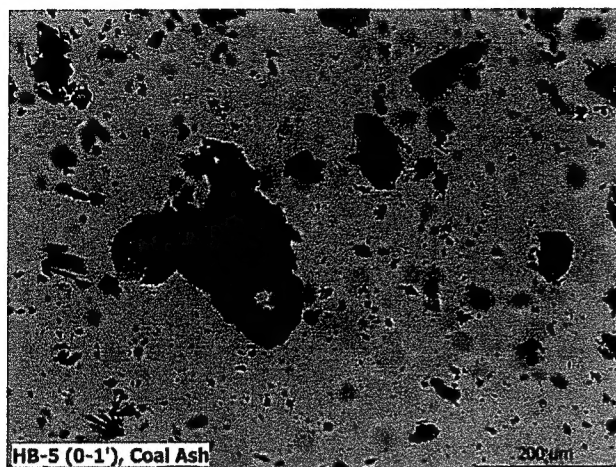
**PLM Image**

**Coal Ash:** This particle type consisted of four (4) dark, porous grains approximately 1-3mm in diameter. The PLM examination indicated this particle type to be consistent with coal ash. The PLM and SEM images show the spherical gas voids that formed during combustion.

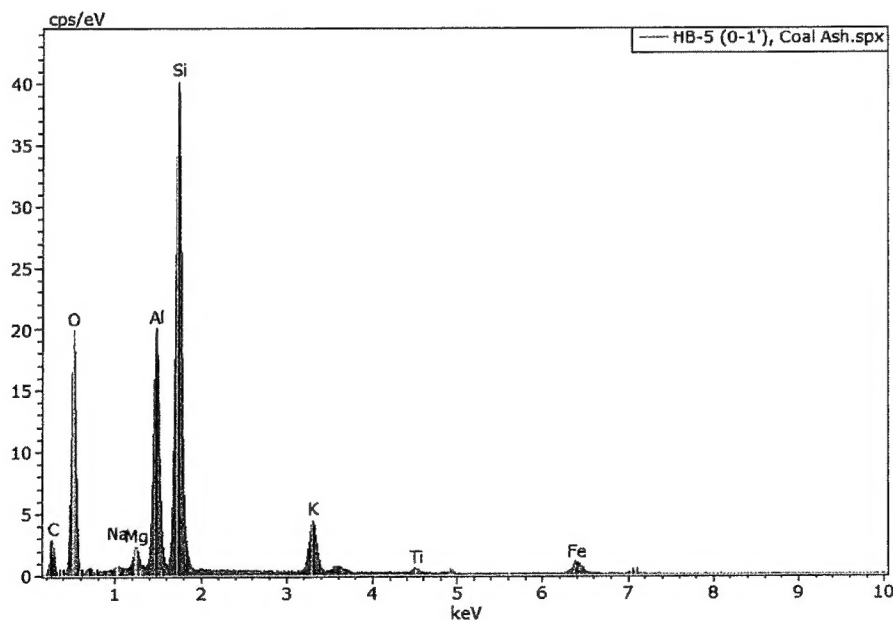
The EDS spectrum, shown below, indicates this particle type is coal ash. The analysis for this particle shows concentrations of carbon, oxygen, sodium, magnesium, aluminum, silicon, potassium, titanium and iron.

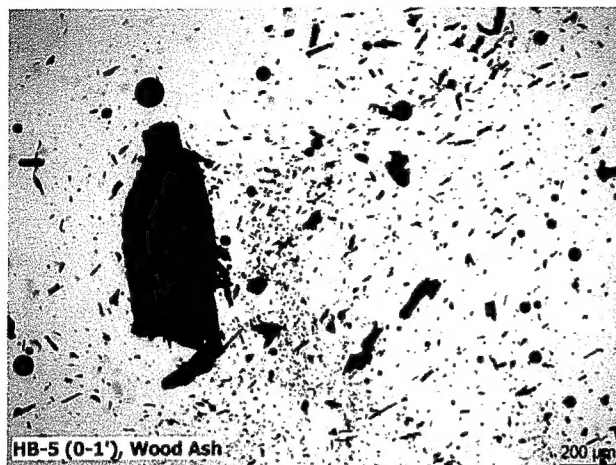
PLM Image

**Wood Ash:** This particle type consisted of two (2) friable, black grains approximately 2mm in length. The PLM examination indicated this particle type to be consistent with wood ash. The PLM and SEM photos show the cellular structure typical of wood still present in these grains.

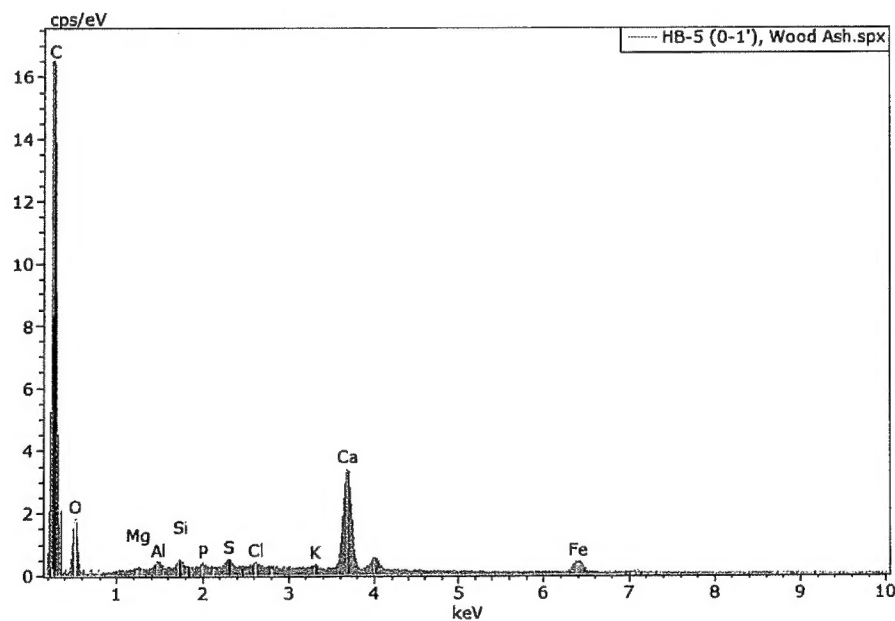
The EDS spectrum, shown below, indicates this particle type is wood ash. The analysis for this particle shows concentrations of carbon, oxygen, magnesium, aluminum, silicon, phosphorus, sulfur, chlorine, potassium, calcium and iron.

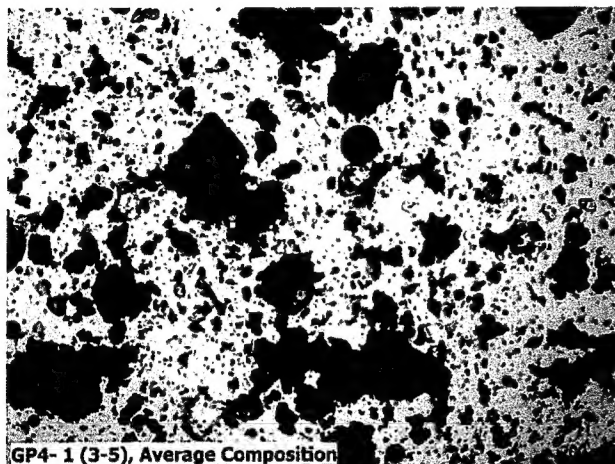
PLM Image

**Minerals:** This particle type consisted of over one hundred (100+) shiny, dark grains 1-10mm in diameter. The PLM examination indicated this particle type to be consistent with mineral matter. The PLM and SEM images of this particle type are shown below.

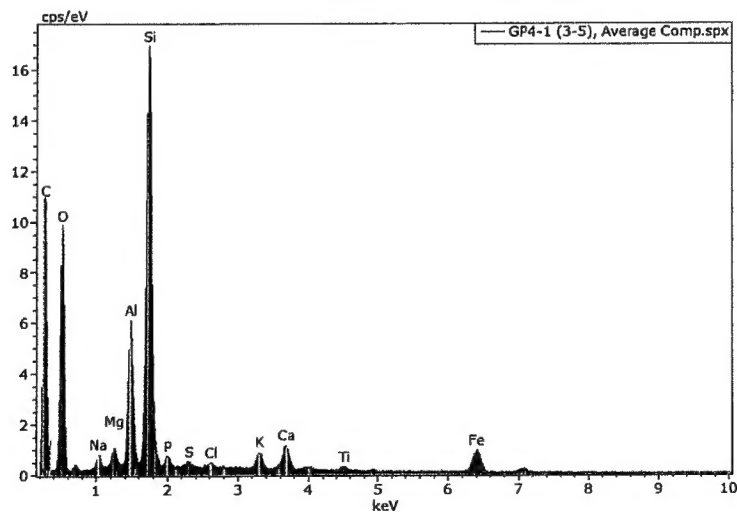
The EDS spectrum results, shown below, indicate this particle type is minerals. The analysis for this particle shows concentrations of carbon, oxygen, sodium, magnesium, aluminum, silicon, phosphorus, sulfur, chlorine, potassium, calcium, titanium and iron.

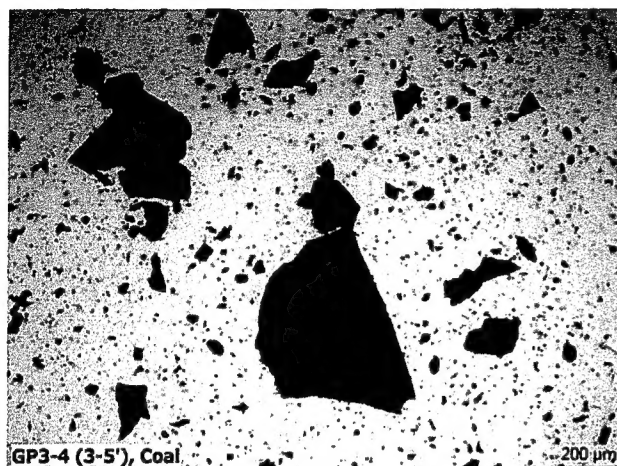
PLM Image

**Coal:** This particle type consisted of six (6) shiny, black grains approximately 1-3mm in diameter. The PLM examination indicated this particle type to be consistent with coal. The PLM and SEM images of this particle type show the angular edges and typical conchoidal fractures found in coal.

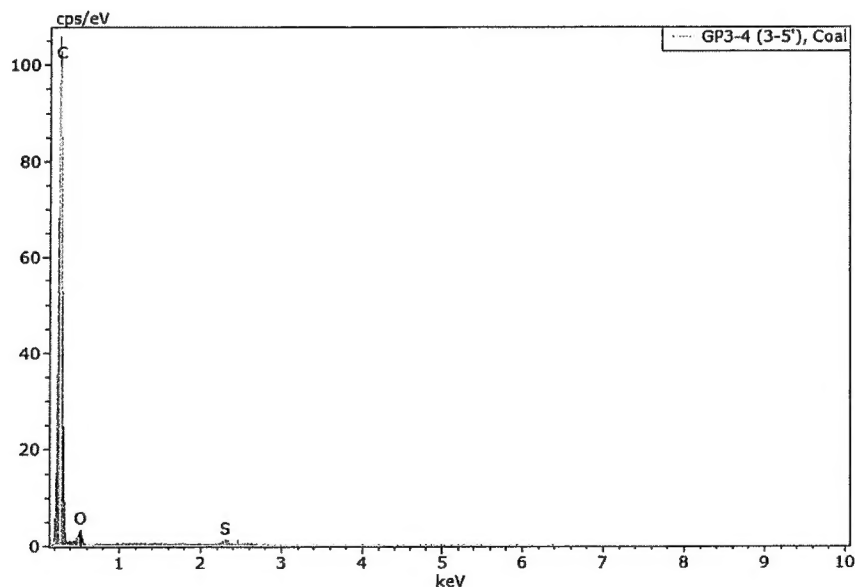
The EDS spectrum, shown below, confirms that this particle type is coal. The analysis for this particle shows concentrations of carbon, oxygen and sulfur.

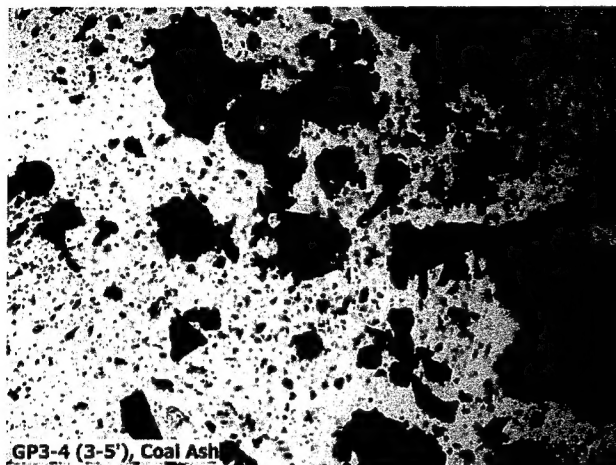
PLM Image

**Coal Ash:** This particle type consisted of two (2) dark, porous grains approximately 2-4mm in diameter. The PLM examination indicated this particle type to be consistent with coal ash. The PLM and SEM images show the spherical gas voids that formed during combustion.

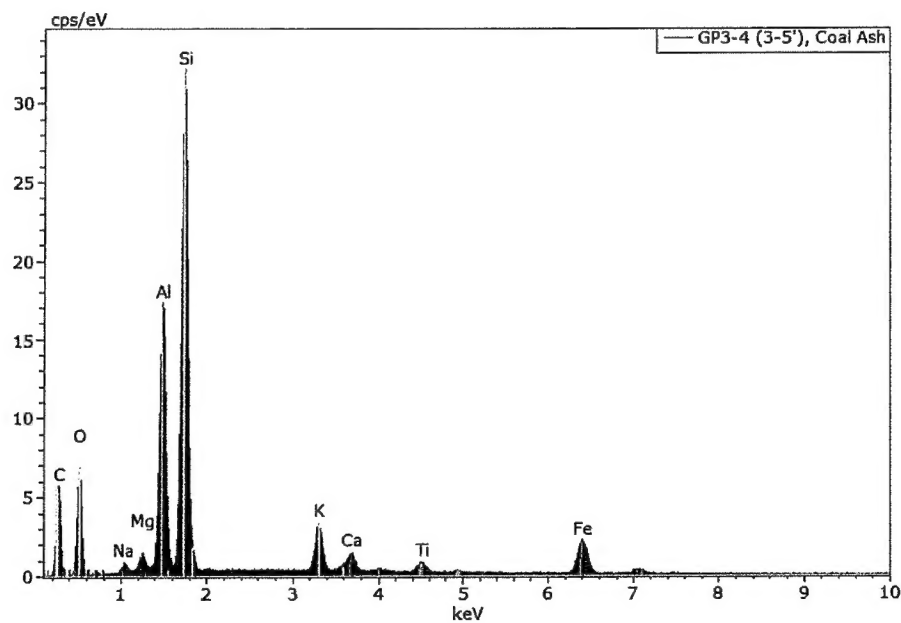
The EDS spectrum, shown below, indicates this particle type is coal ash. The analysis for this particle shows concentrations of carbon, oxygen, sodium, magnesium, aluminum, silicon, potassium, calcium, titanium and iron.
